Significant Incident Report: London Luton Airport Terminal Car Park 2

10/10/2023, Terminal Car Park 2, Easy Way, Luton, Bedfordshire. GB-040100-2023

Bedfordshire
Fire & Rescue Service

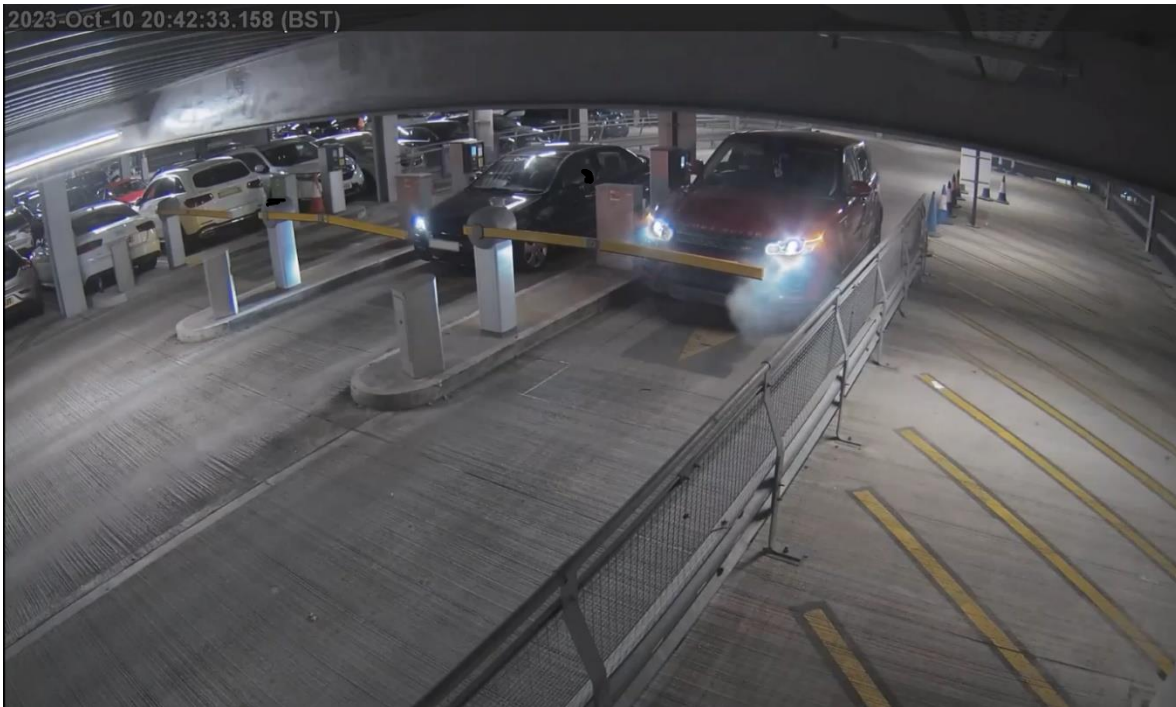
Figure 2: CCTV showing vehicle stopped at the ticket barrier with smoke from the bonnet at 20:42:33

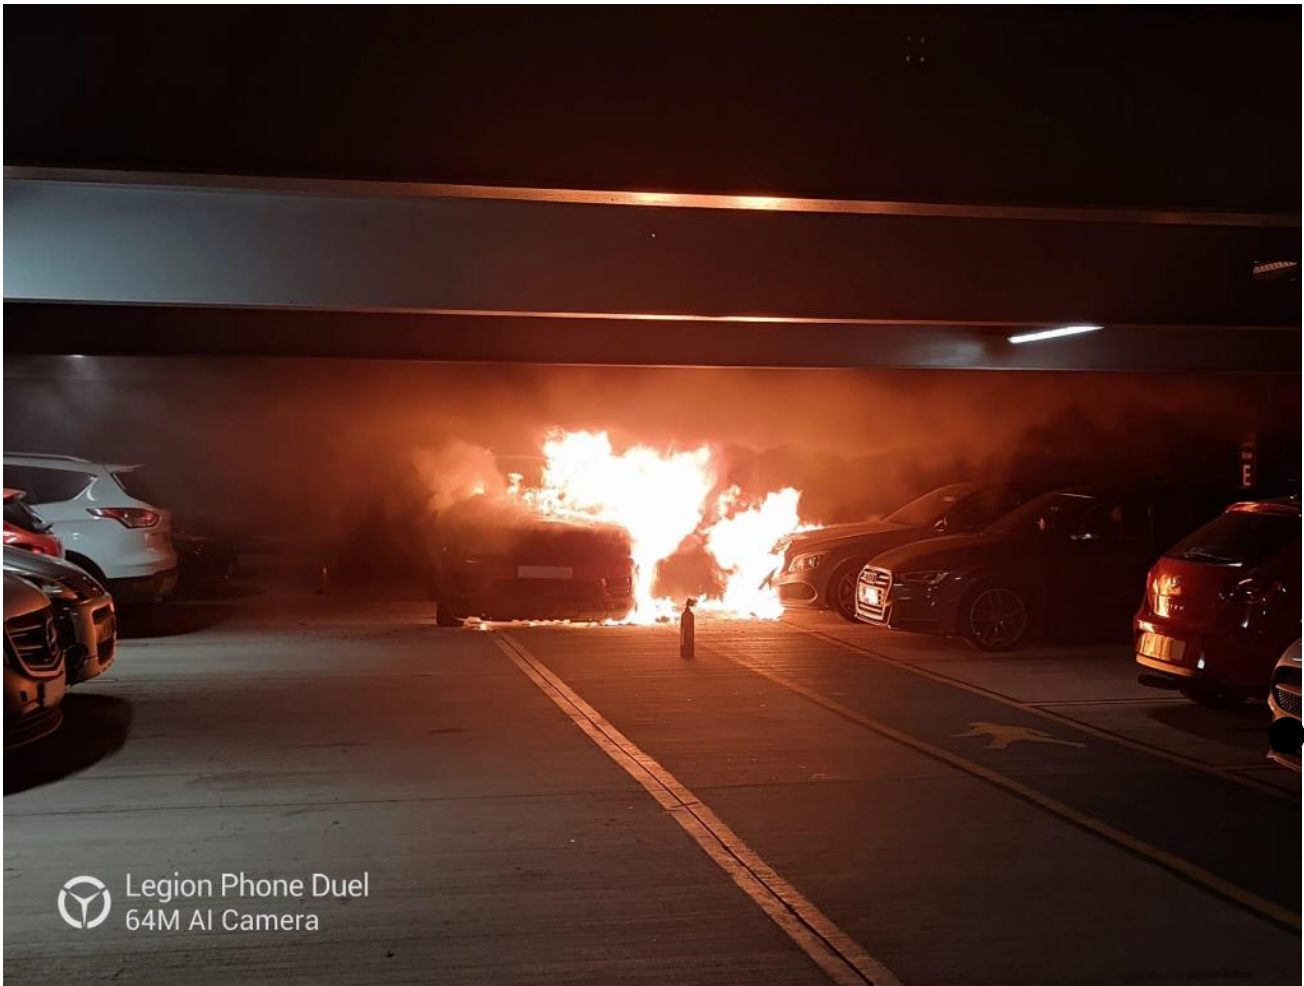
Figure 3 - Car park employee digital image – Red Range Rover on third floor TCP2 on fire

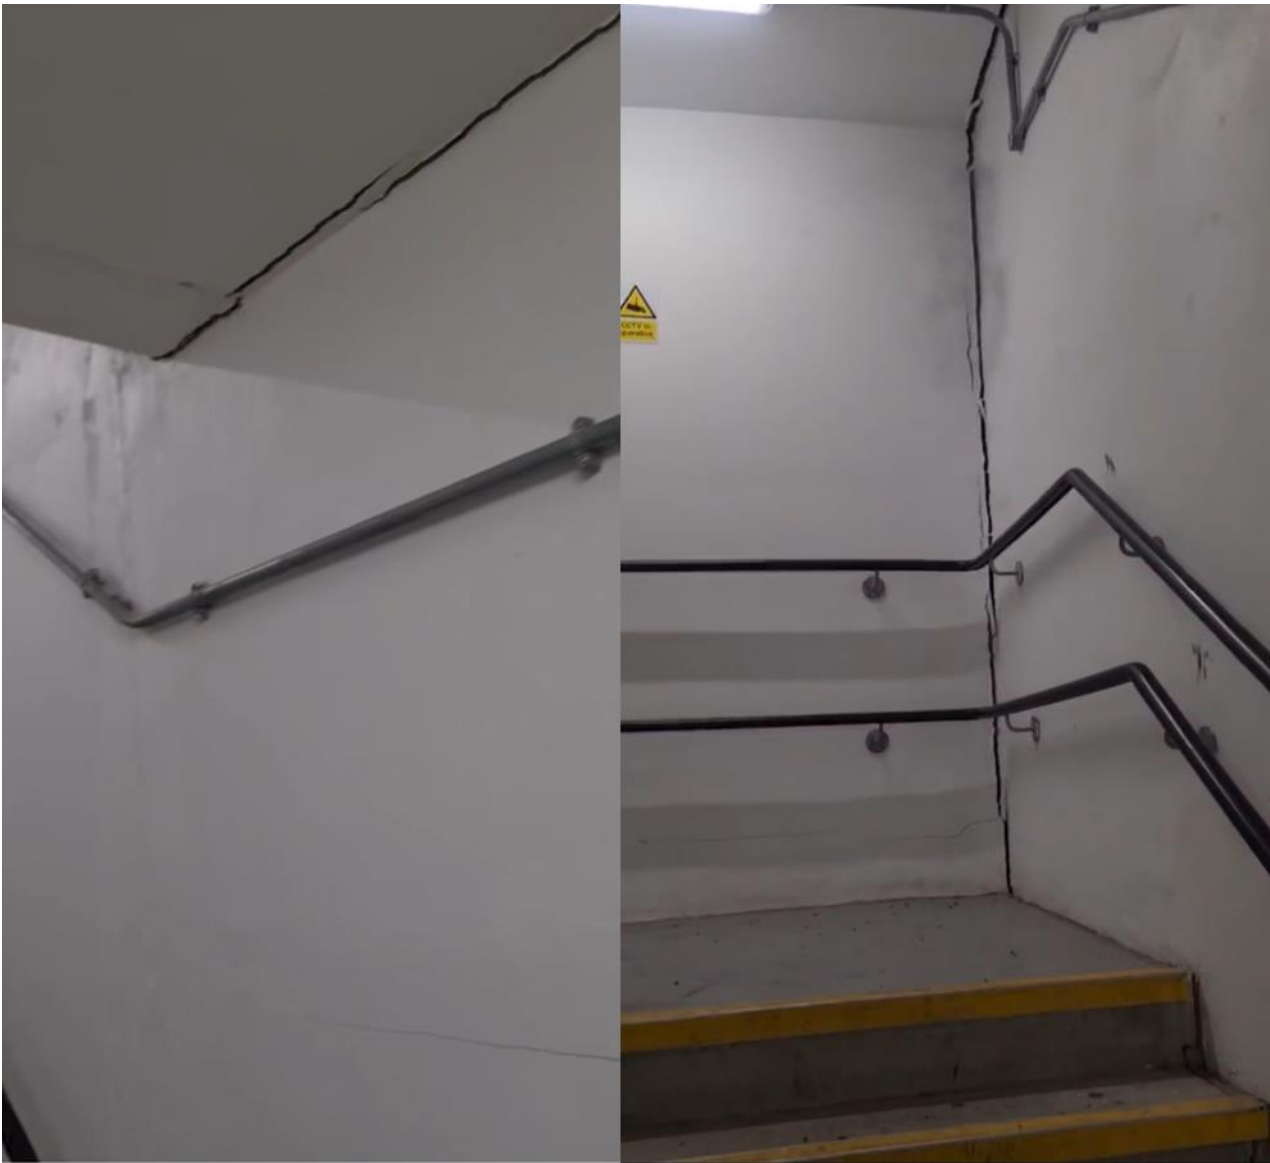
Figure 5 Signs of structural damage in the Northwest Stairwell

At about this time Watch Commander A stated via radio to Group Commander A that 'internally the incident was escalating and there were signs of internal structural damage within the stairwell and concrete floor.'¹¹⁶ Based on this information Group Commander A took the decision to 'evacuate all crews from internal firefighting and to re assess our tactics'¹¹⁷ An informative message was sent to Service Control at 21:26:46 that 'all crews now withdrawn from structure external FF now in place awaiting AP TMD'¹¹⁸

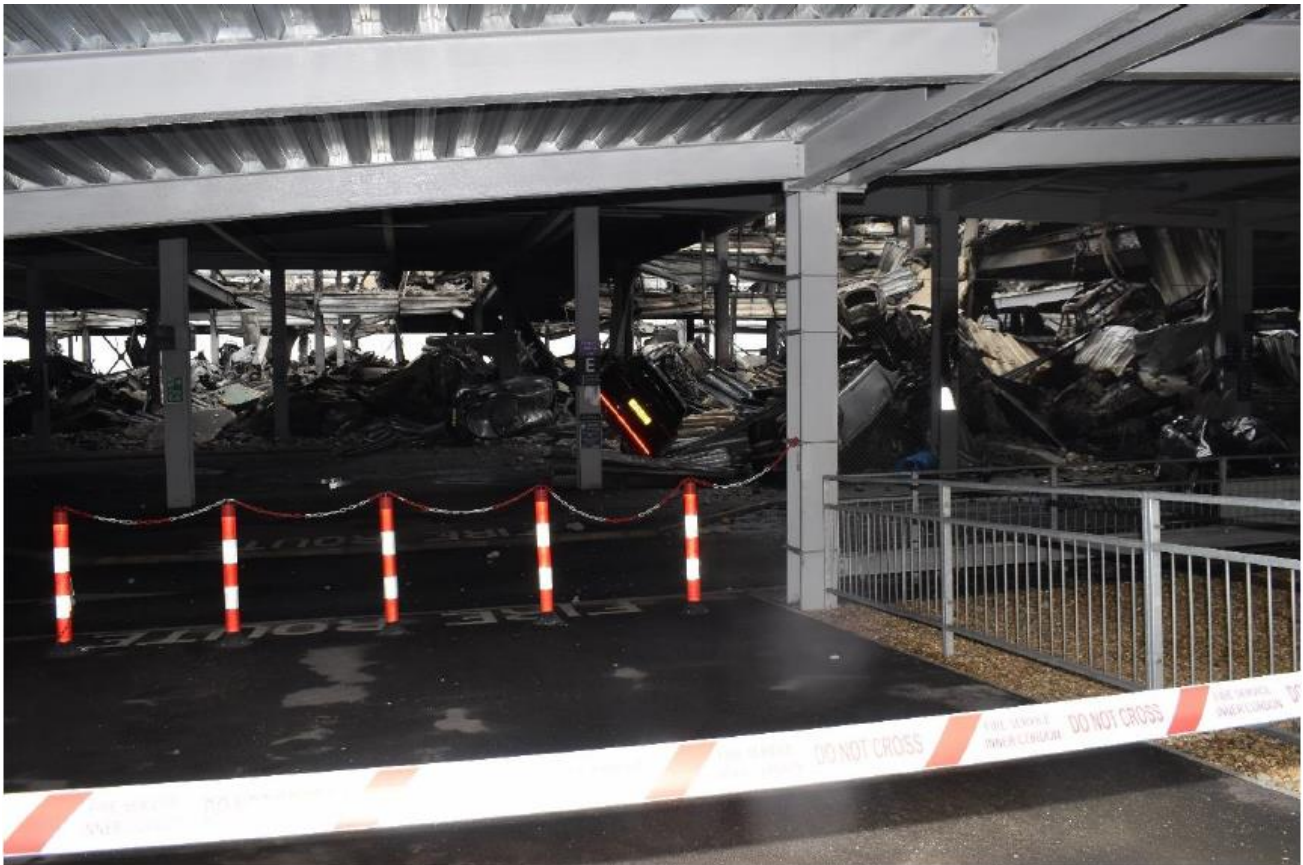
Figure 7 – Image showing building collapse post fire. Image is used courtesy of Bedfordshire Police

Shortly after this there was a loud noise and elements of the structure and burning cars could be seen dropping down to ground level into the area used as the drop off and pick up area of the car park.⁵⁶

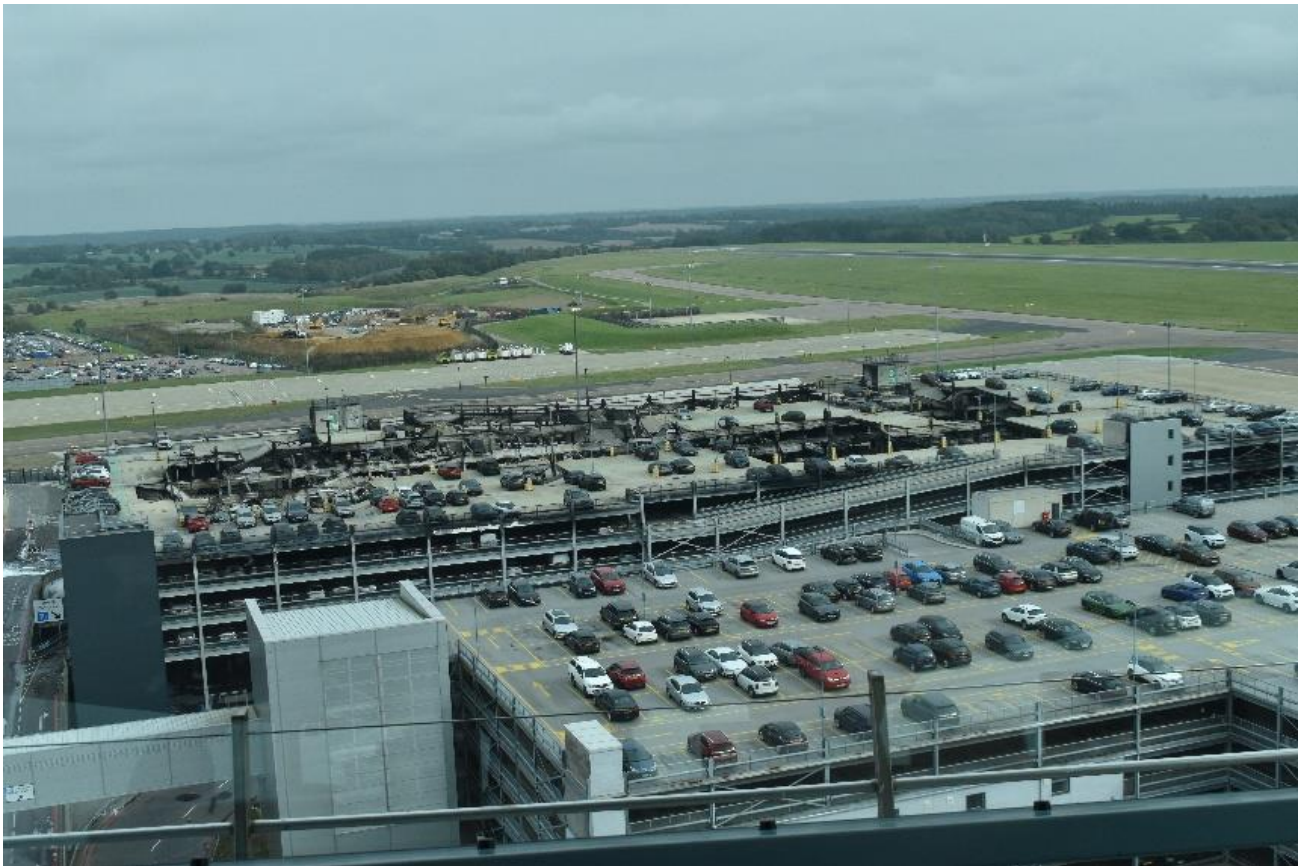
Figure 8 Car Parks 1 and 2 following the fire. Image courtesy of Bedfordshire Police

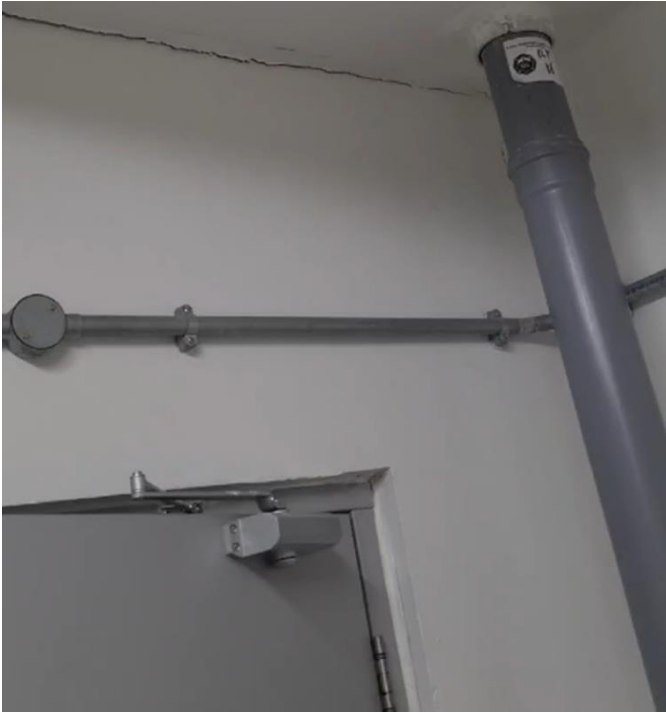
Figure 15 Example of plastic drainage pipe
