Significant Incident Report: London Luton Airport Terminal Car Park 2

10/10/2023, Terminal Car Park 2, Easy Way, Luton, Bedfordshire. GB-040100-2023

Bedfordshire
Fire & Rescue Service

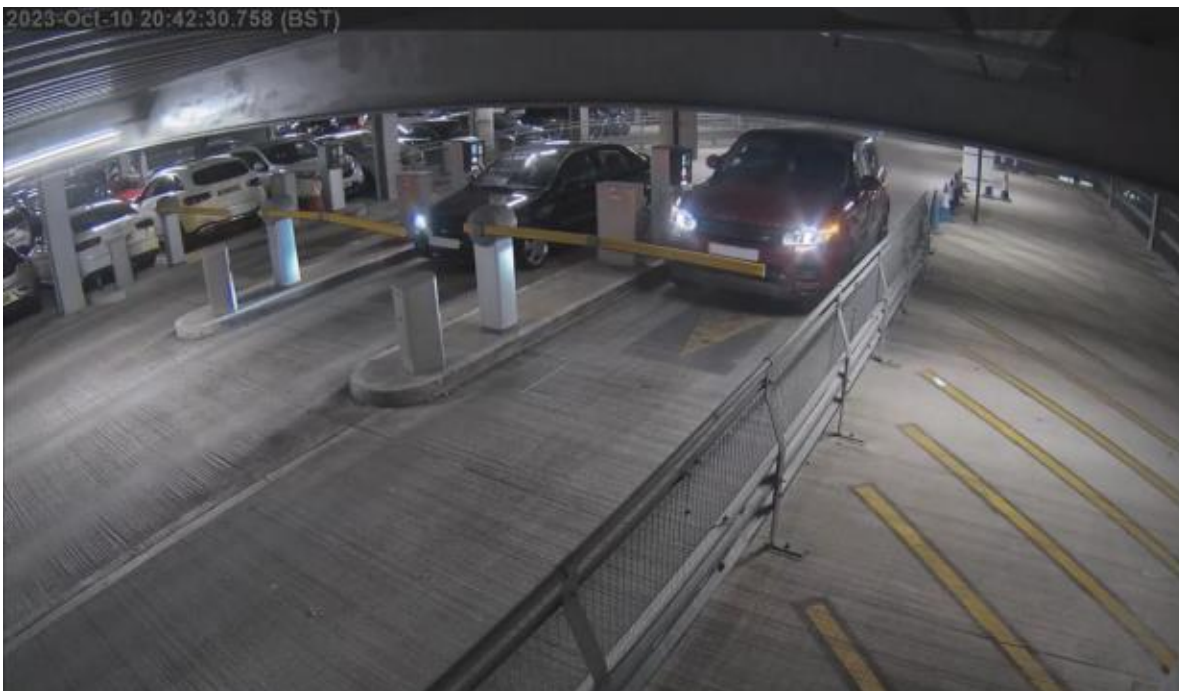
At 20:42 on Tuesday 10 October 2023, CCTV captures a red Range Rover Sport arriving at the ticket barrier at London Luton Airport (LLA) Terminal Car Park 2. As the vehicle stops at the barrier, light smoke can be seen issuing from the vehicle. The smoke is light in colour and is issuing from the nearside of the engine compartment. The vehicle proceeds through the barrier and continues to drive internally to the third floor where the driver notices visible flames from the front of the vehicle, bringing it to a stop on the car park roadway.⁴

Figure 1 CCTV showing the Range Rover before it stops at 20:42:30

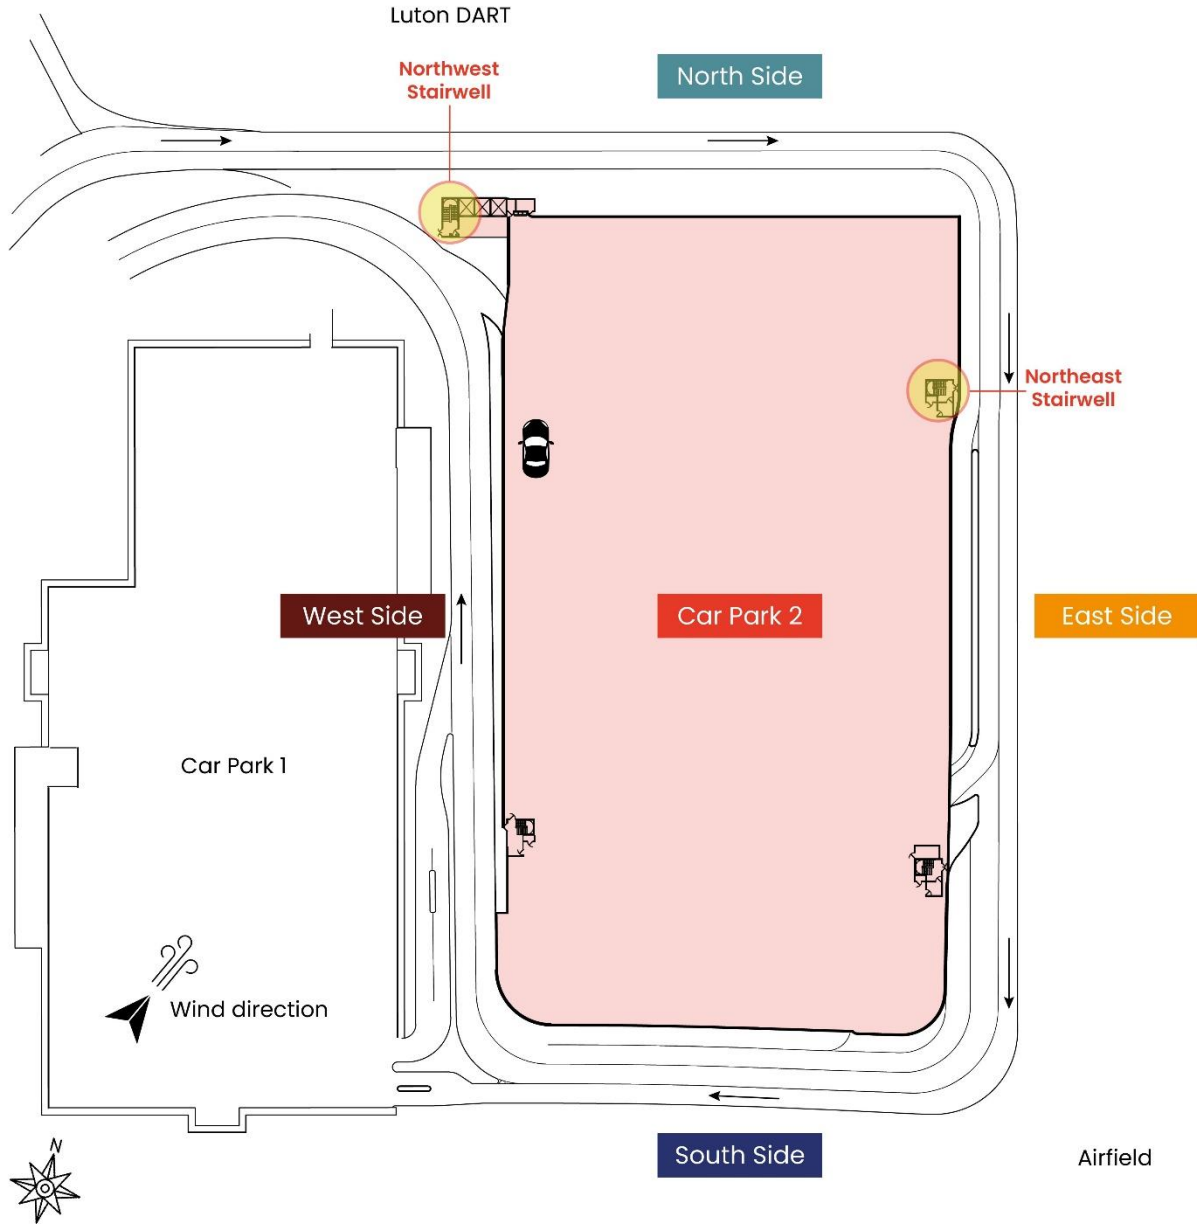
Figure 4 Map of site showing the approximate location on the third floor of the vehicle of origin (vehicle not to scale)

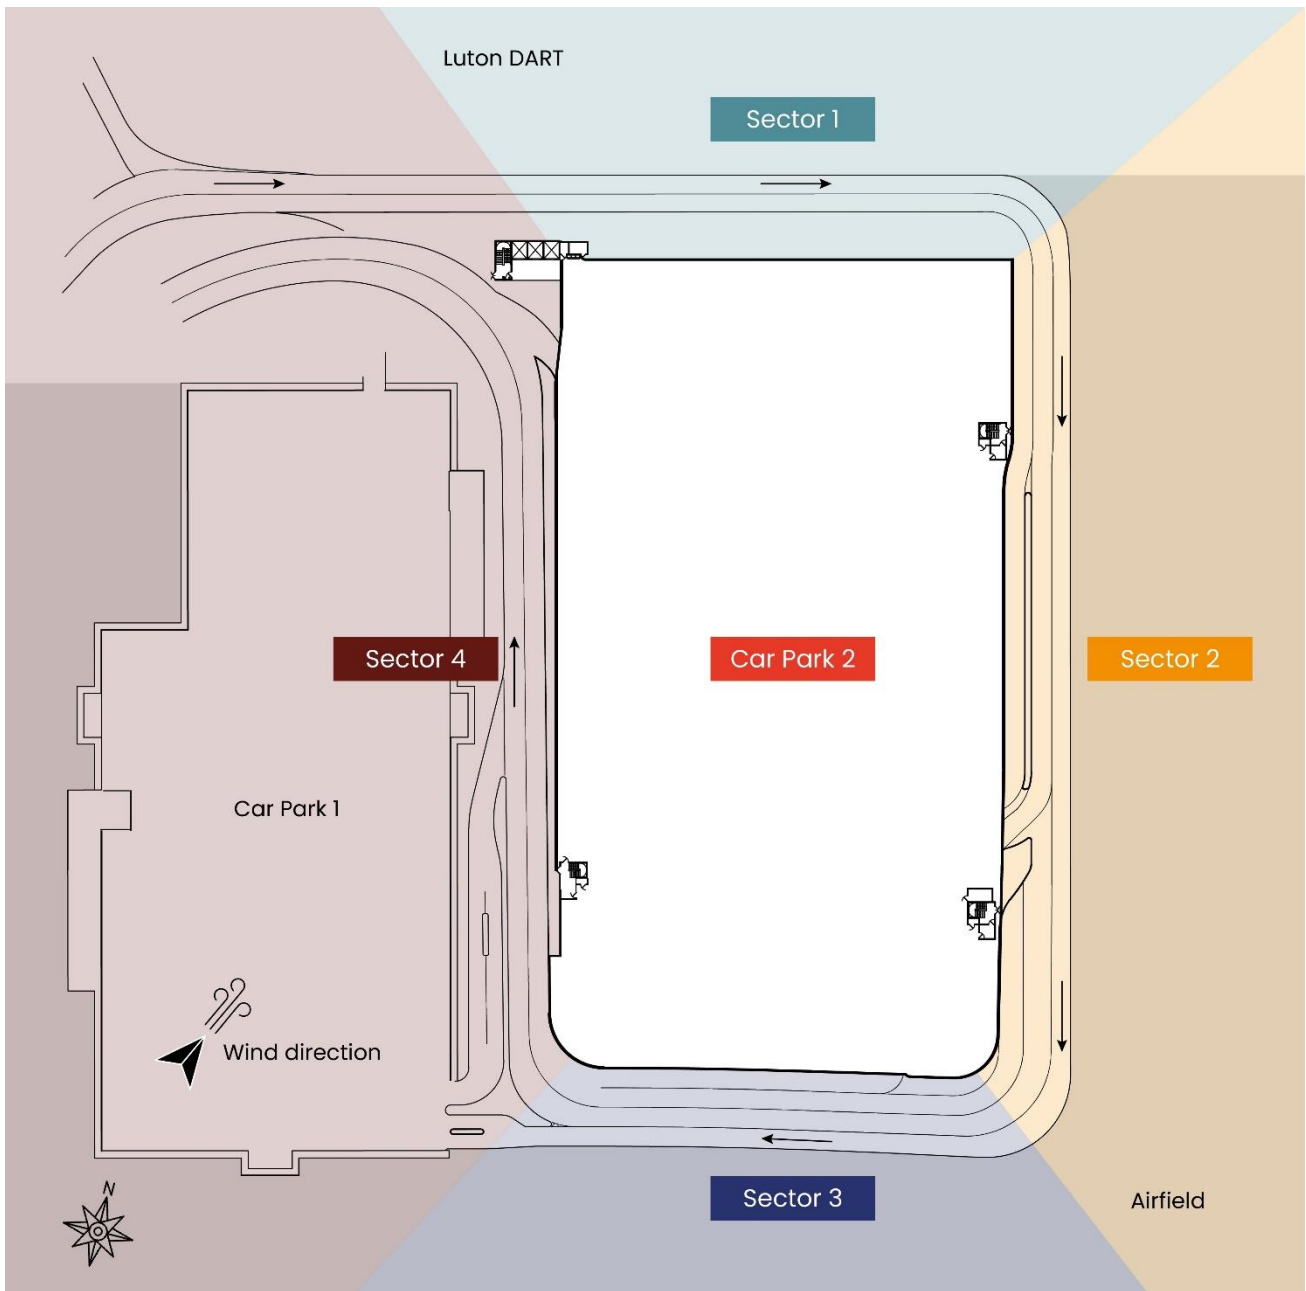
Figure 6 – Sectorisation of Incident

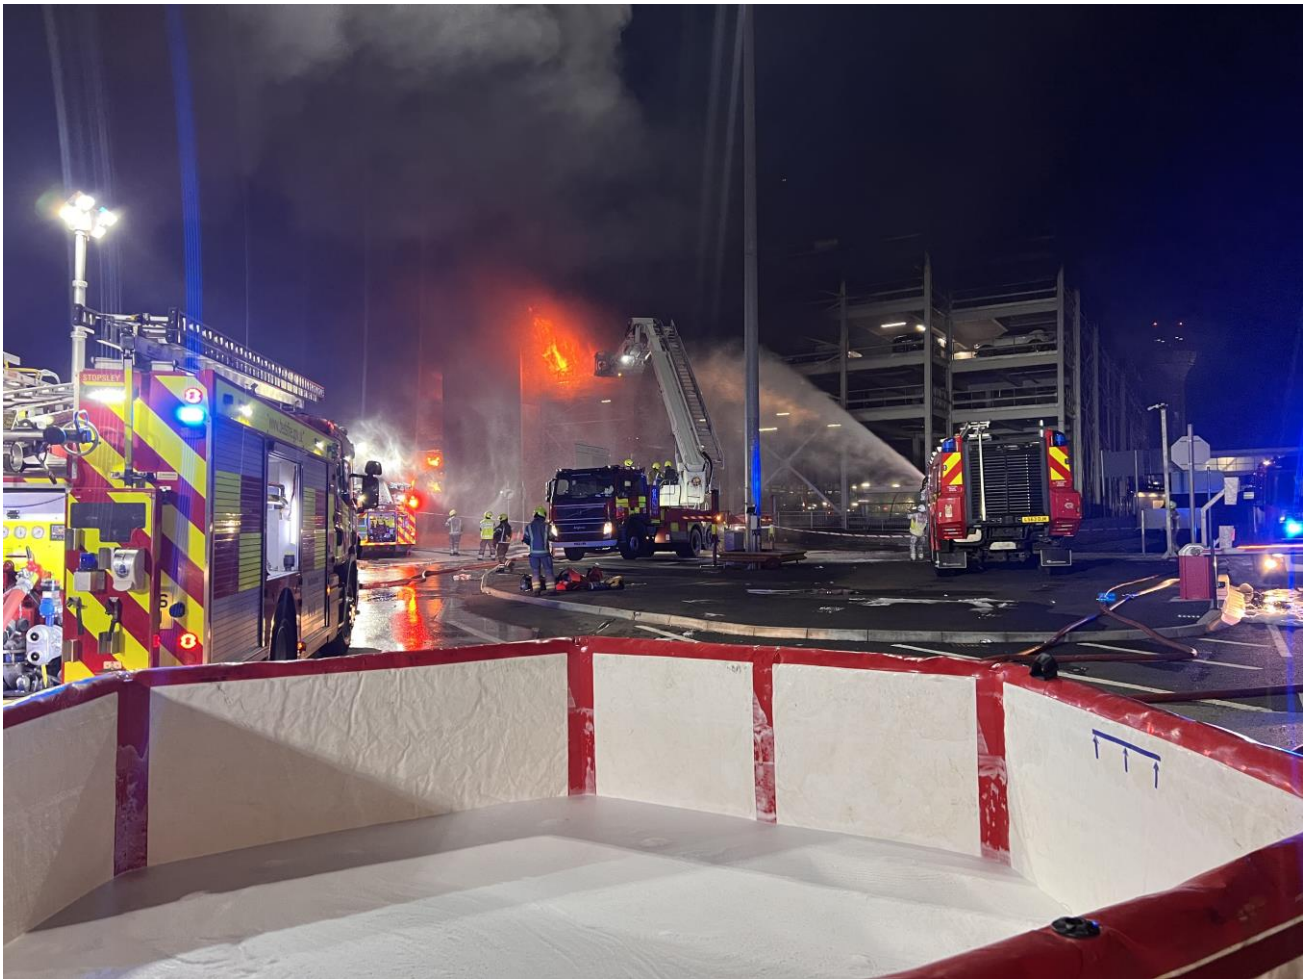
Figure 9 Water damn in use

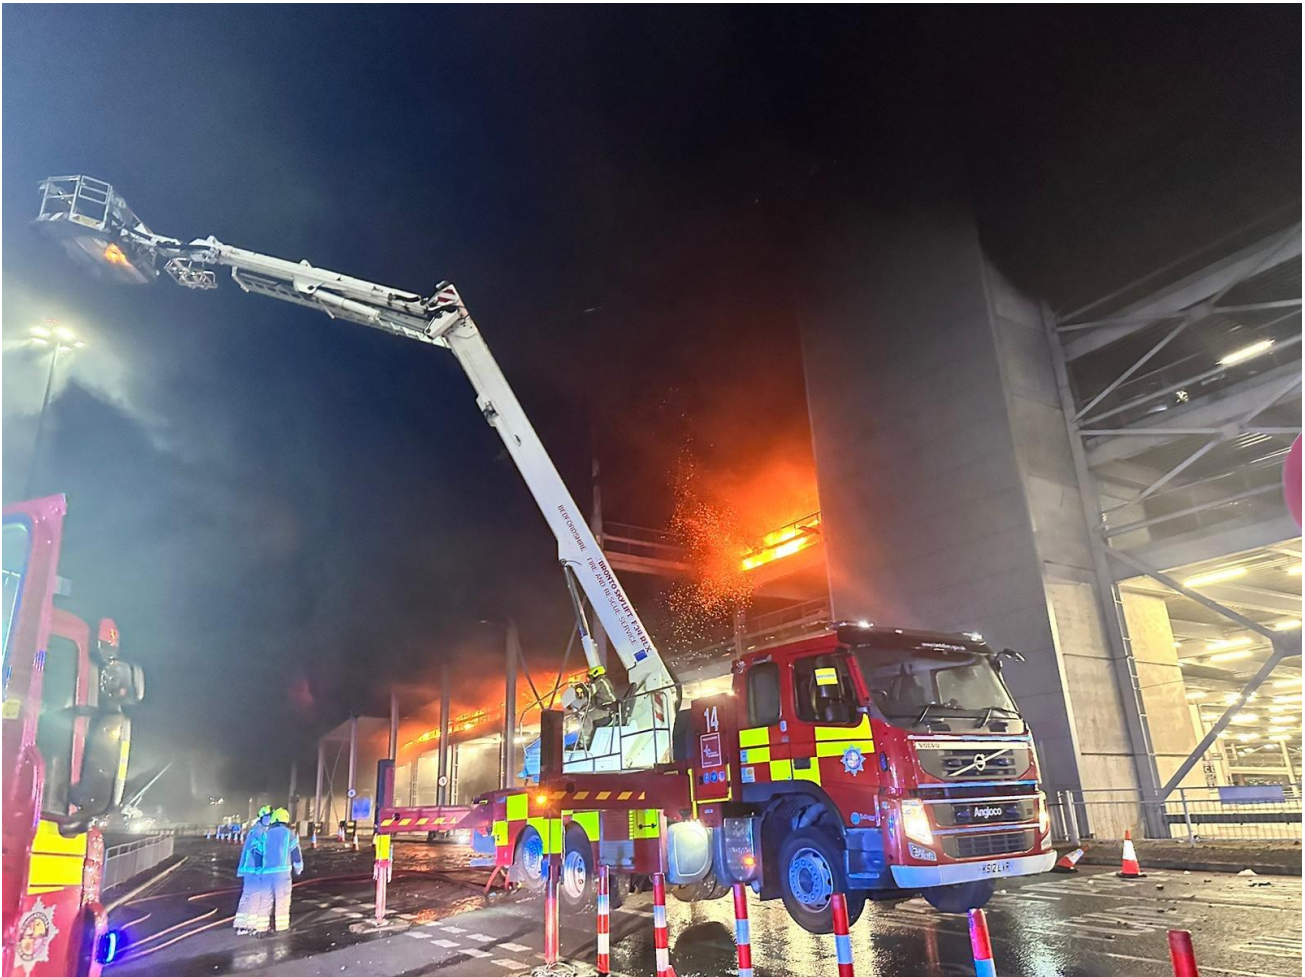
Figure 11 – Aerial Appliance from Bedford

Bedfordshire FRS has an aerial platform that is primary crewed based at Luton Fire Station. This was not available on Tuesday 10 October 2023 because of maintenance. As a result, the first aerial appliance sent came from Bedford and took 36 minutes to arrive from the time it was requested. Bedford Fire Station is approximately 26 miles from LLA. Stevenage Fire Station where the second Aerial Appliance is based is approximately 15 miles from LLA. The delay in aerial appliances arriving was noted in the internal debrief.¹³⁰
